THE UNITED STATES  
STRATEGIC BOMBING SURVEY

# THE ELECTRIC POWER INDUSTRY OF JAPAN

(Plant Reports)

Electric Power Division

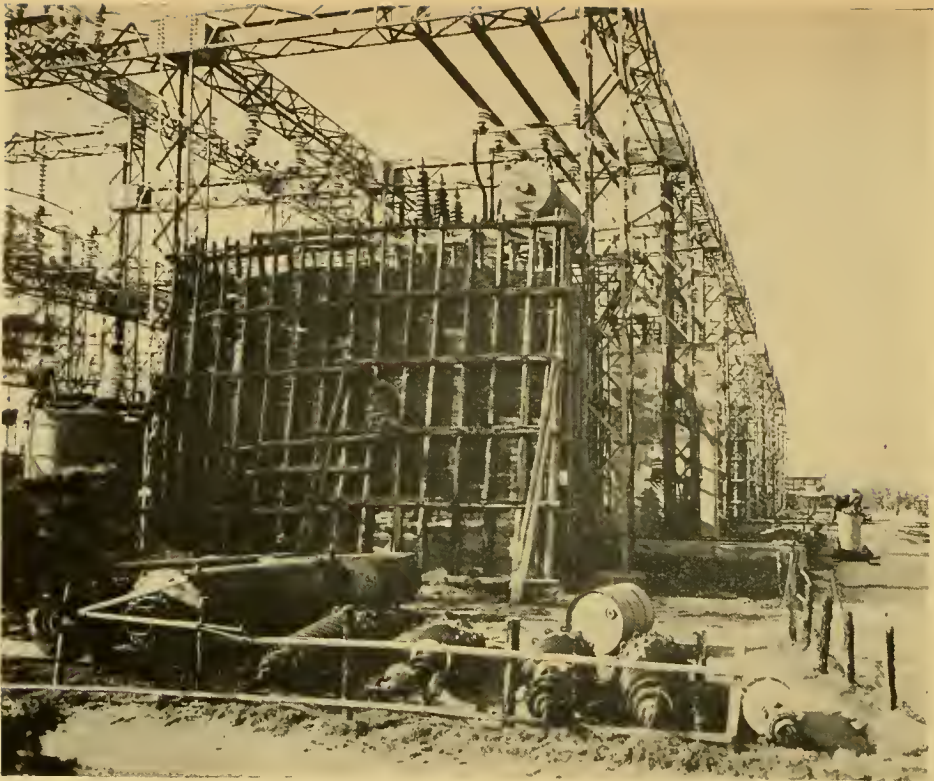
Photo 3—Damaged lightning arrestors and blast wall

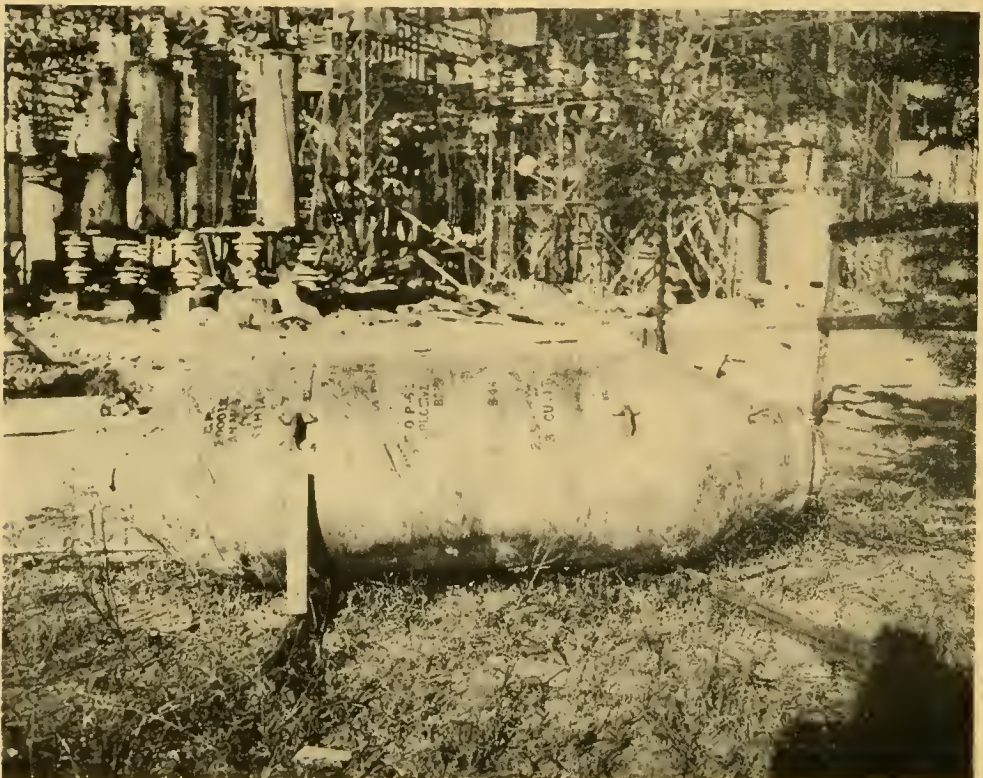
Photo 4—2,000 lb. unexploded bomb (12-inch stick on left)

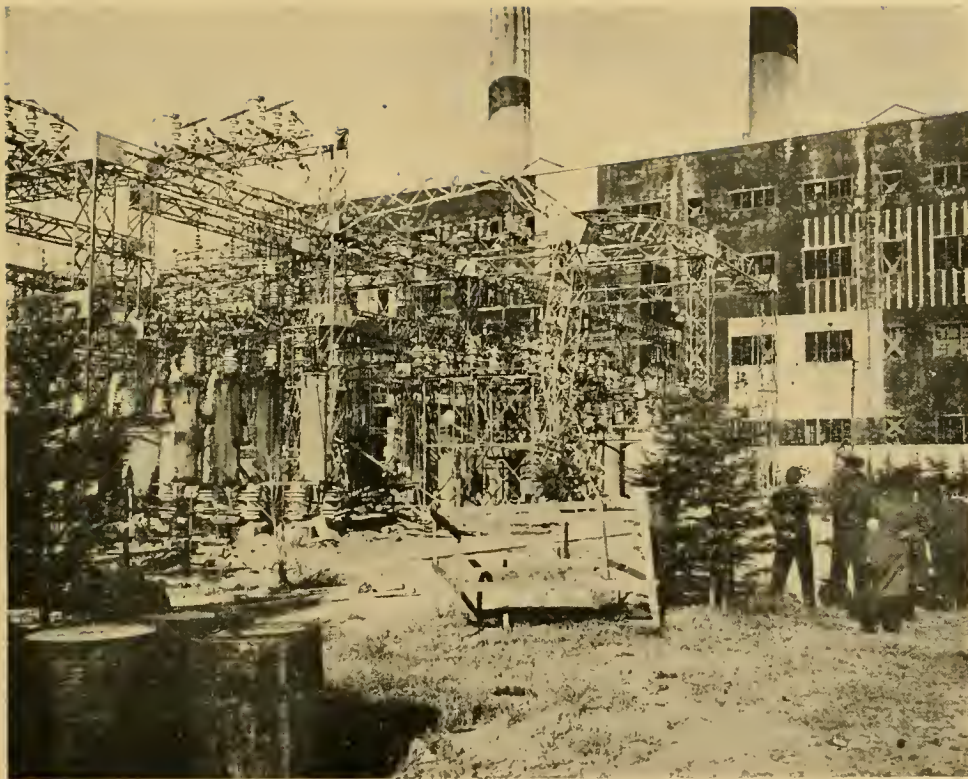
Photo 5—Damage to arrestors and substation

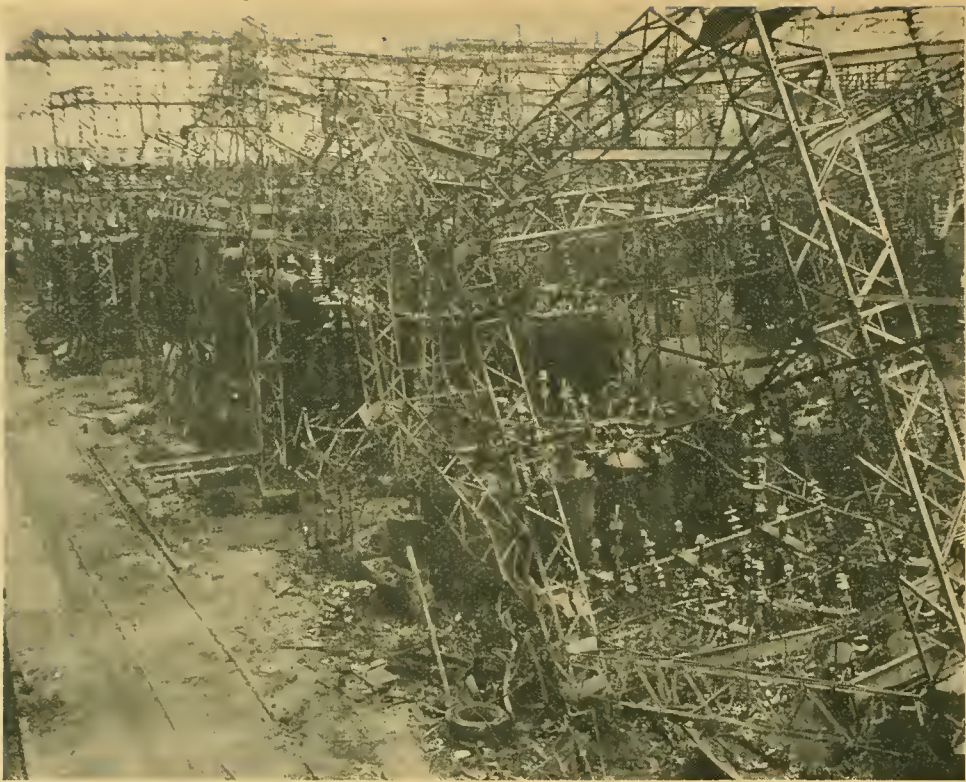
Photo 7—View of damaged switch and transformer yard

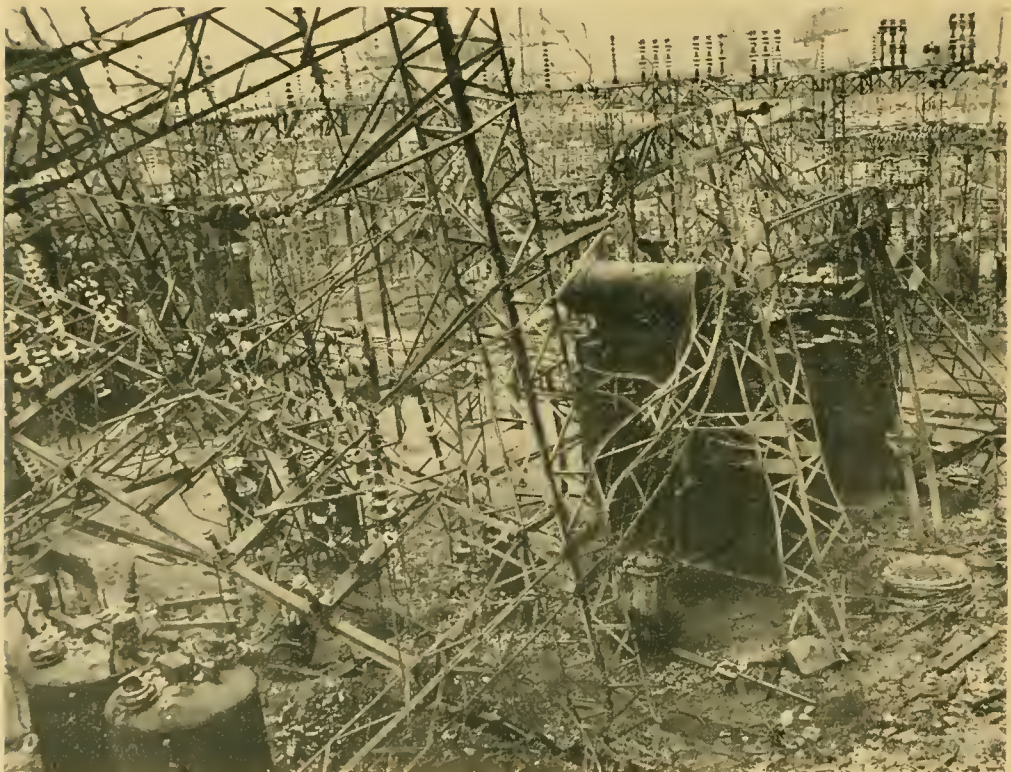
Photo 8—View of damaged switch and transformer yard

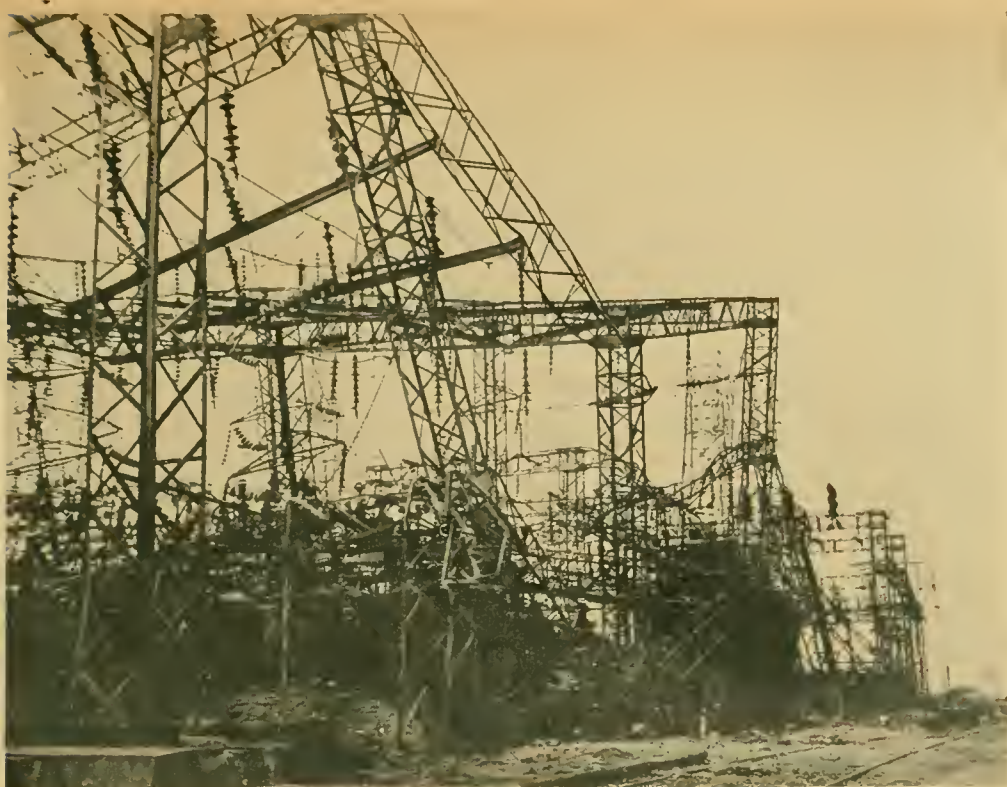
Photo 9—Ground view of damaged switch and transformer yard

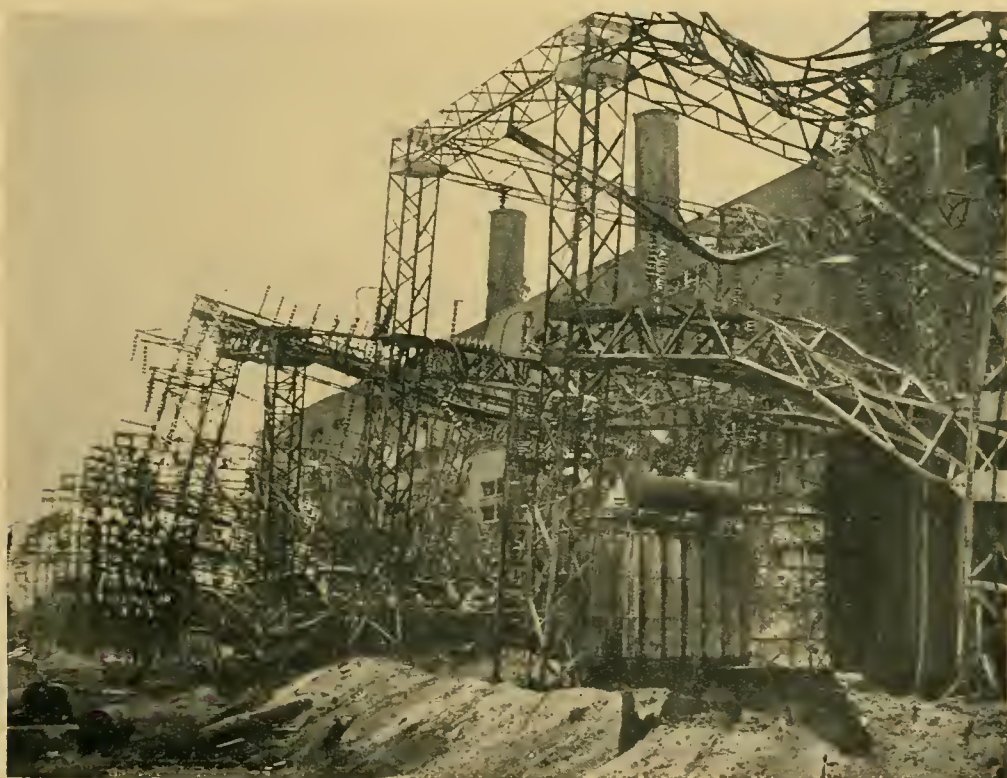
Photo 10—Ground view of damaged switch and transformer yard

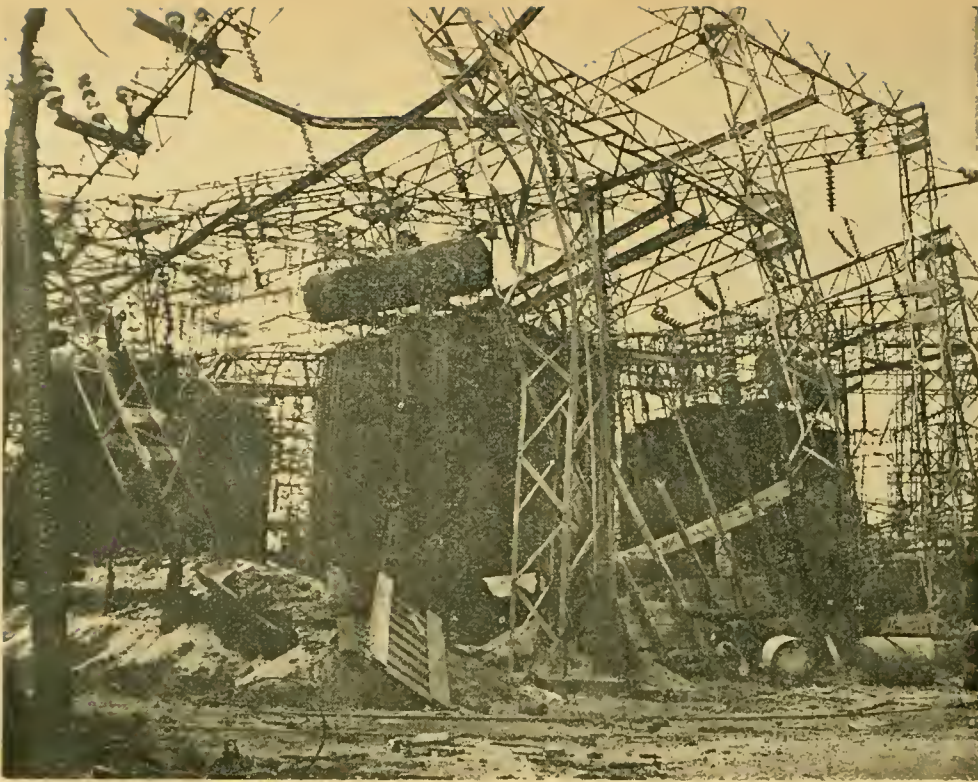
Photo 11—Closer view of damaged switch and transformer yard

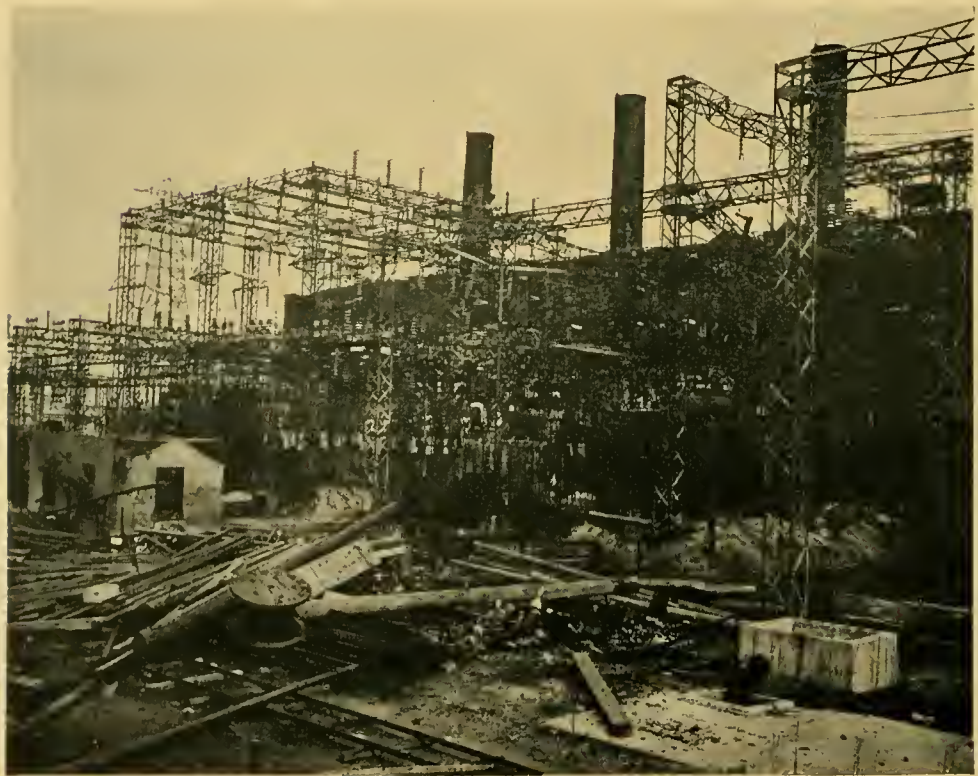
Photo 12—General view of part of switch and transformer yard showing some of damaged section

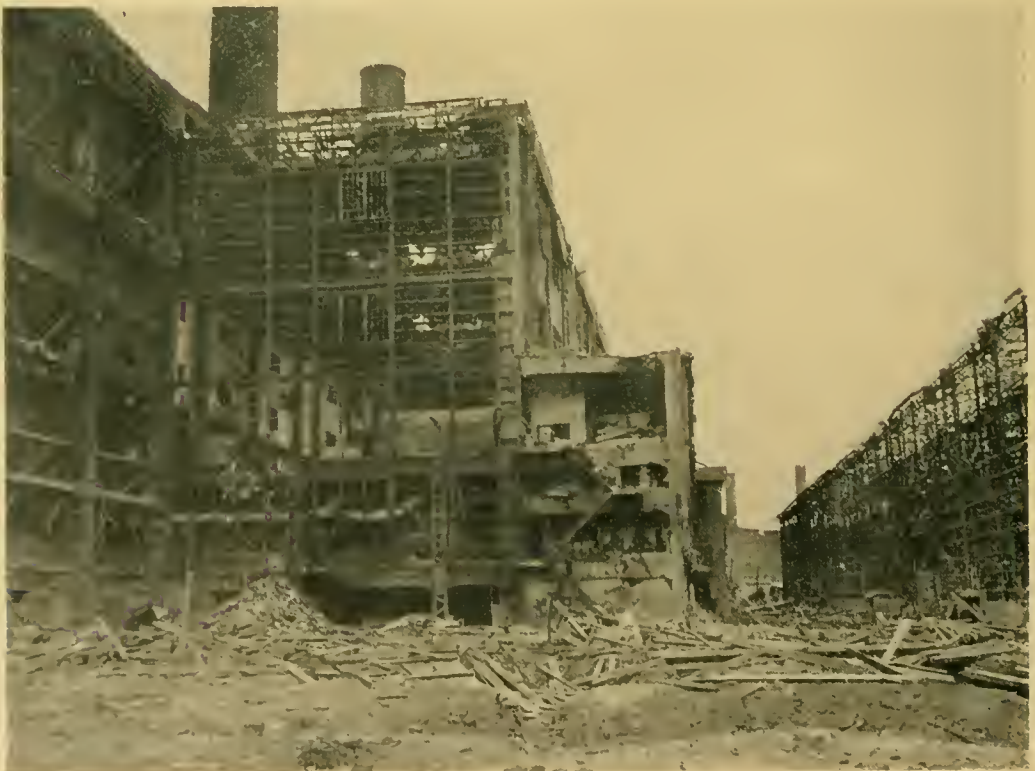
Photo 2—Closer view of damaged boiler, turbogenerator, and control section of plant at left and indoor transformer and switching building at right looking north

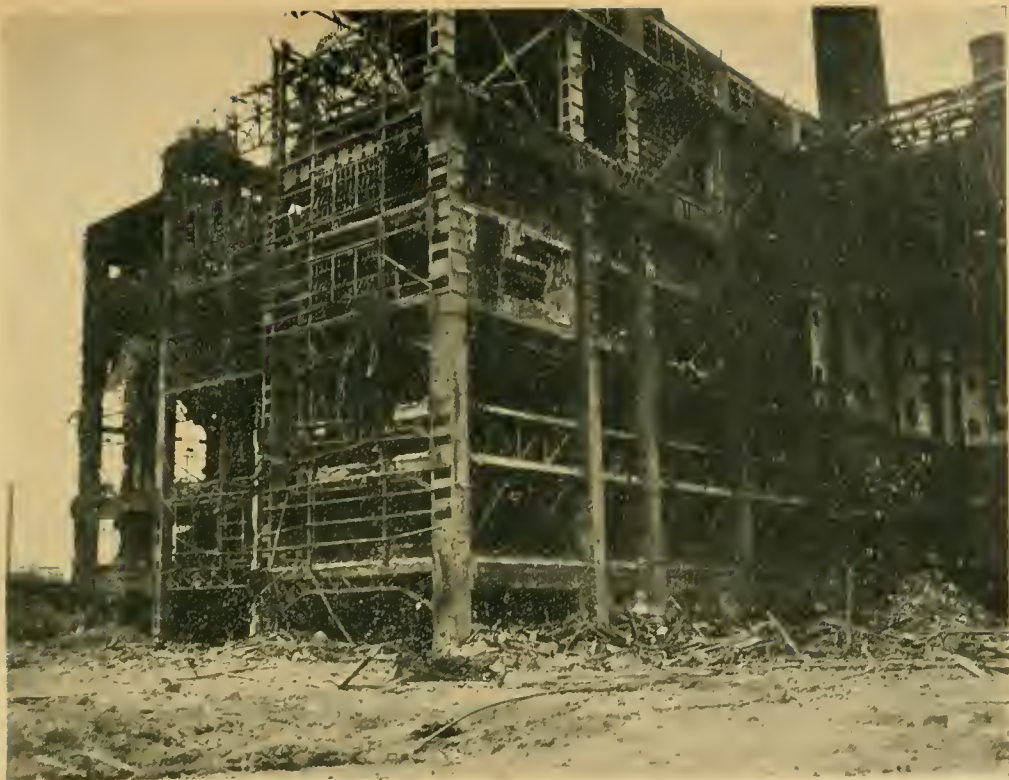
Photo 3—View of damaged south end of boiler house

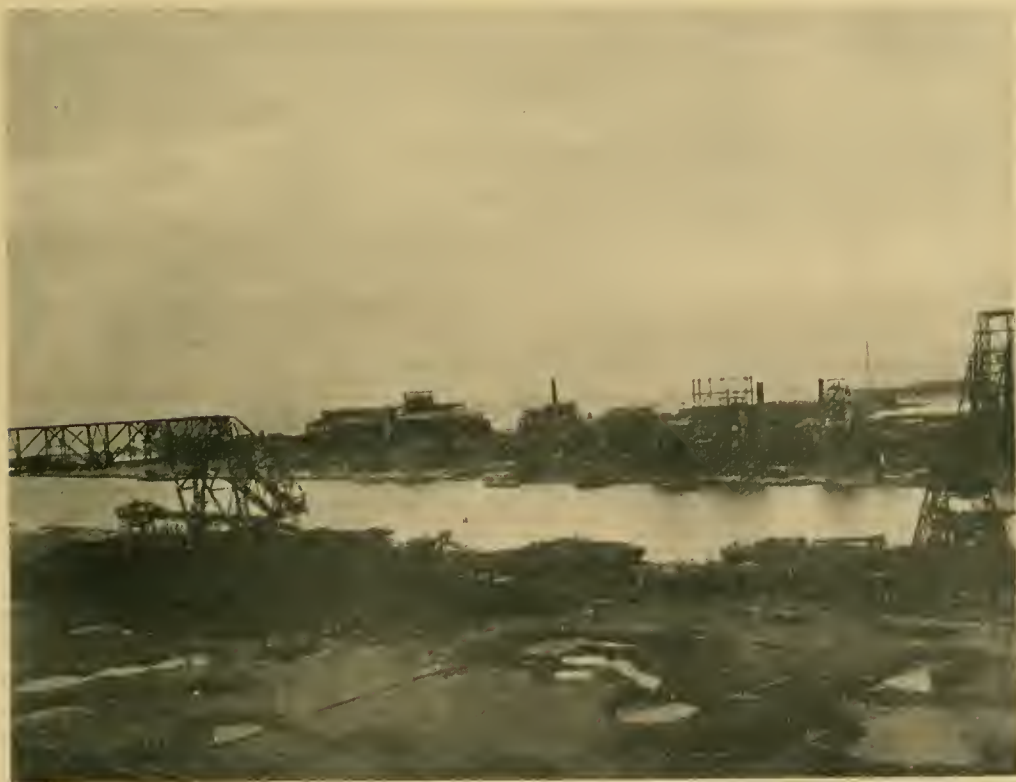
Photo 4—View looking west from top of boiler house showing damaged coal handling equipment with Nippon Oil Refinery across canal

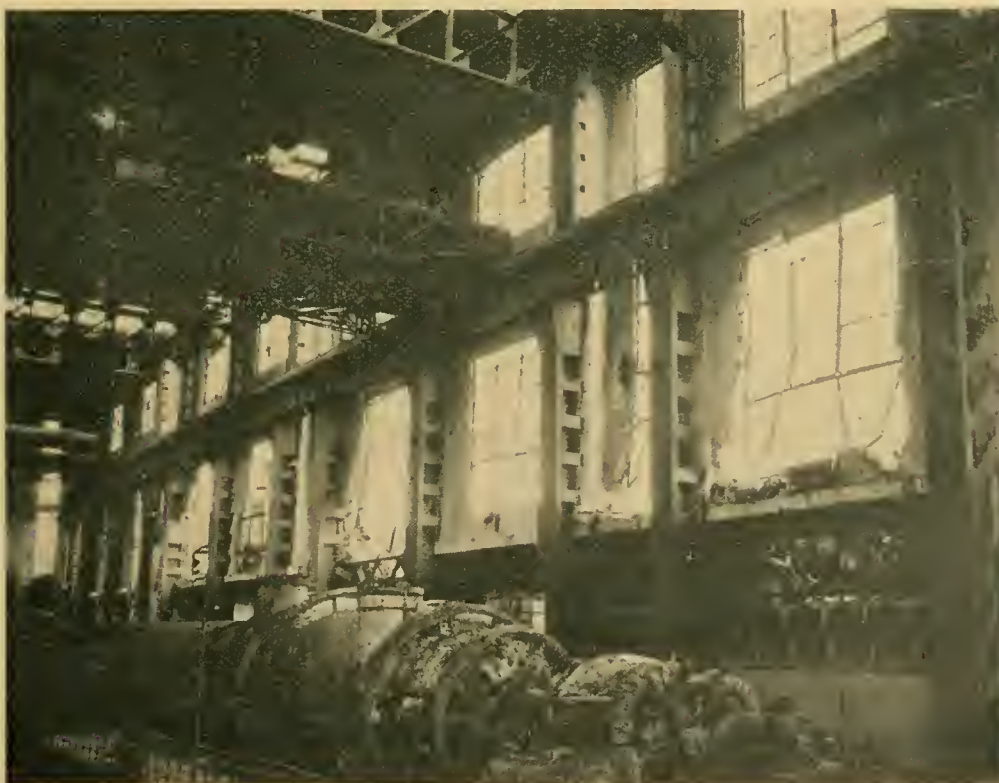
Photo 8—View showing damaged turbogenerator unit and building damage.

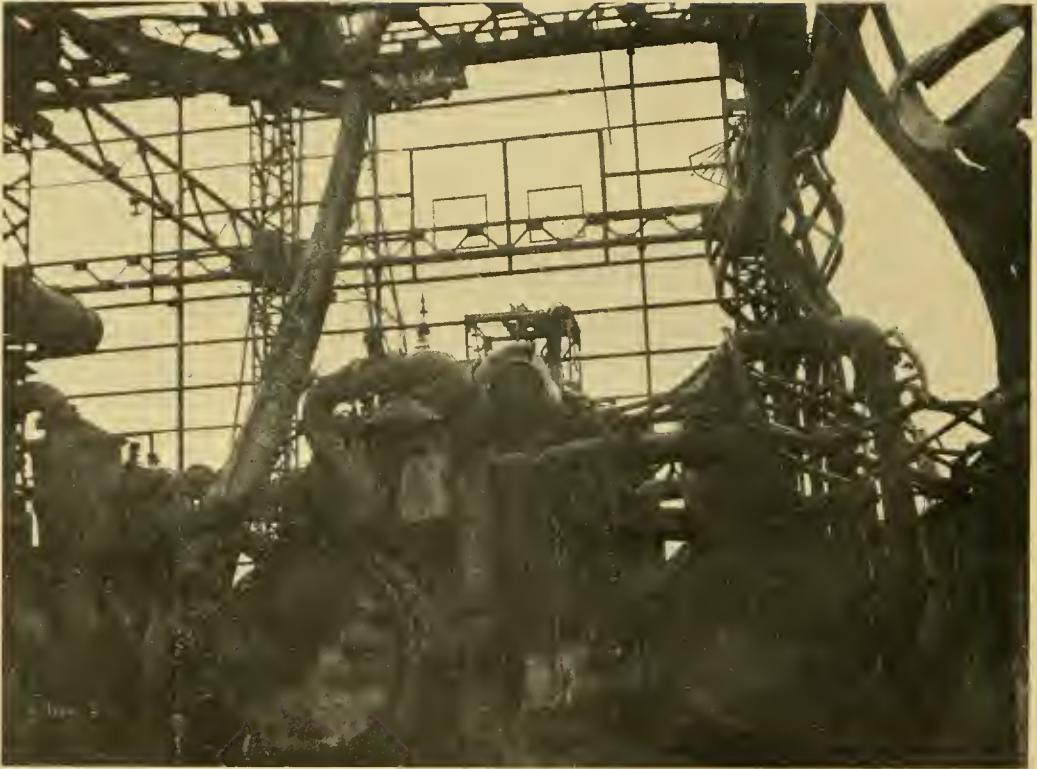
Photo 13—View of damaged oil coolers for main transformers, station transformer directly behind

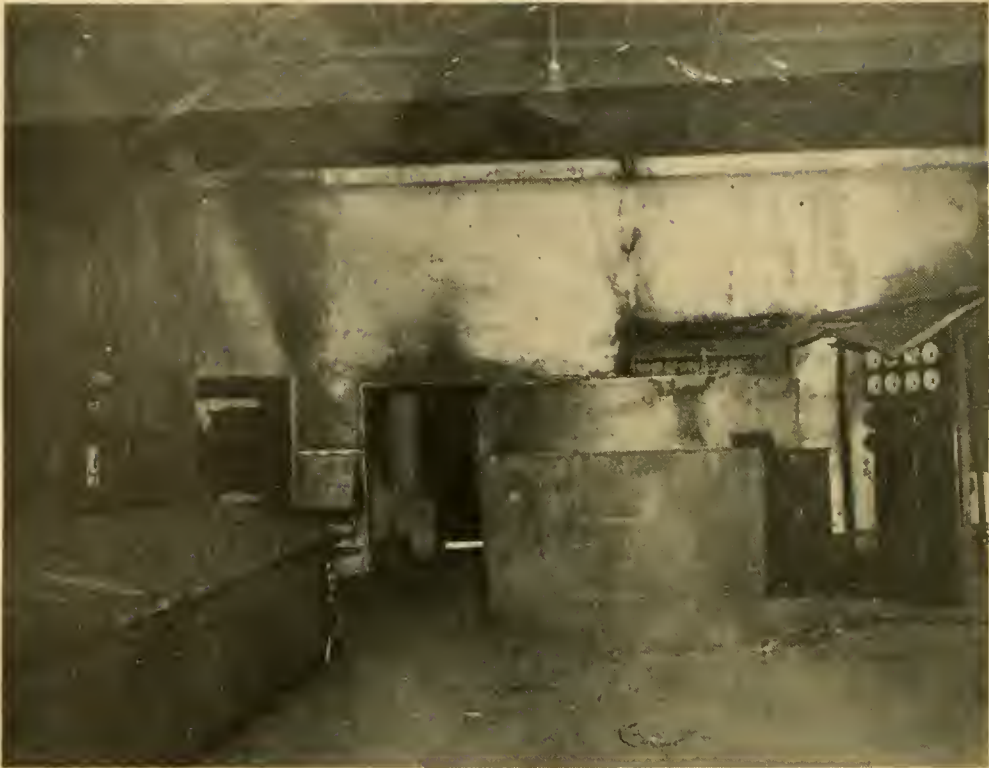
Photo 1—View showing damaged control desk and auxiliary panels and also damaged shelter

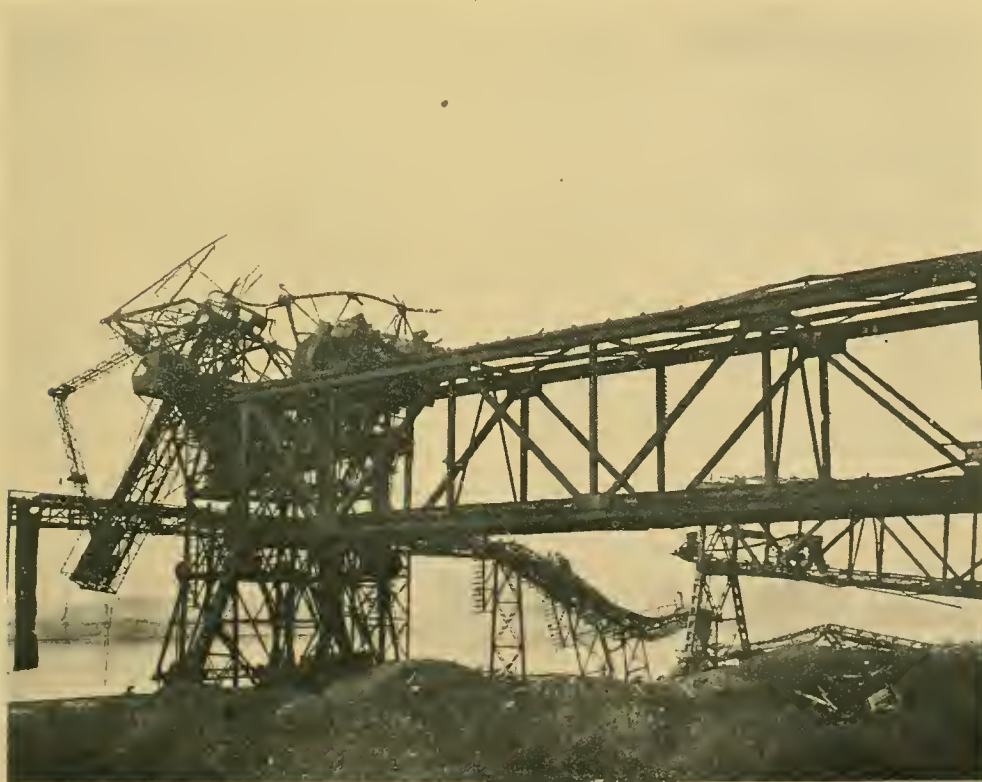
Photo 2—View of damaged unloading crane and conveyors

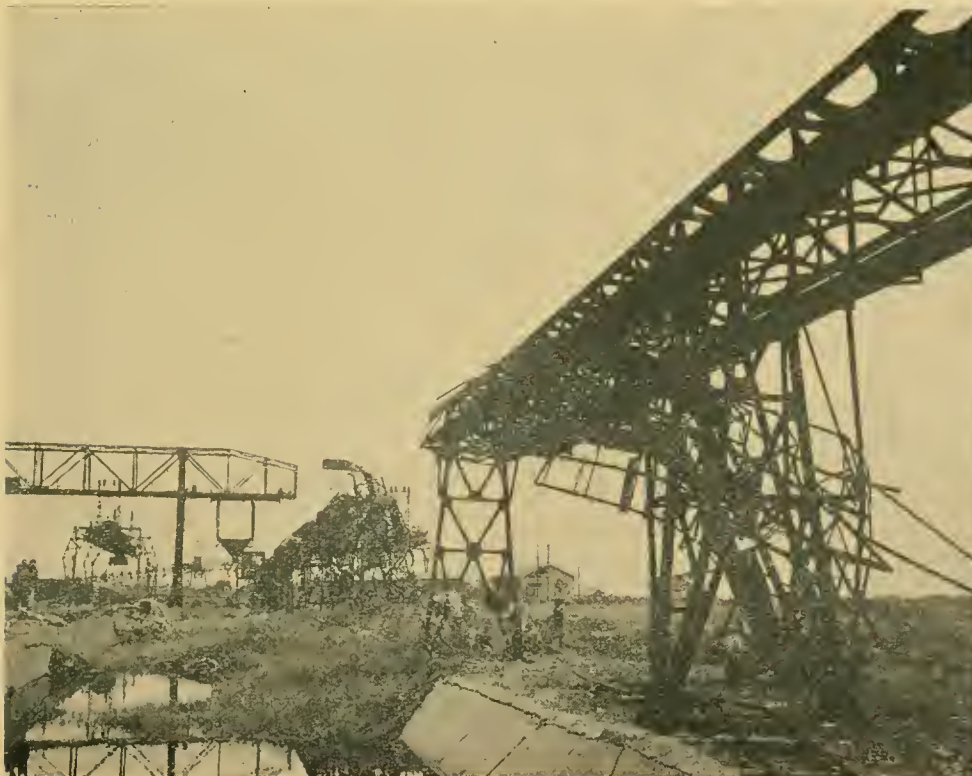
Photo 2—Damaged coal conveyors—Raid number 1

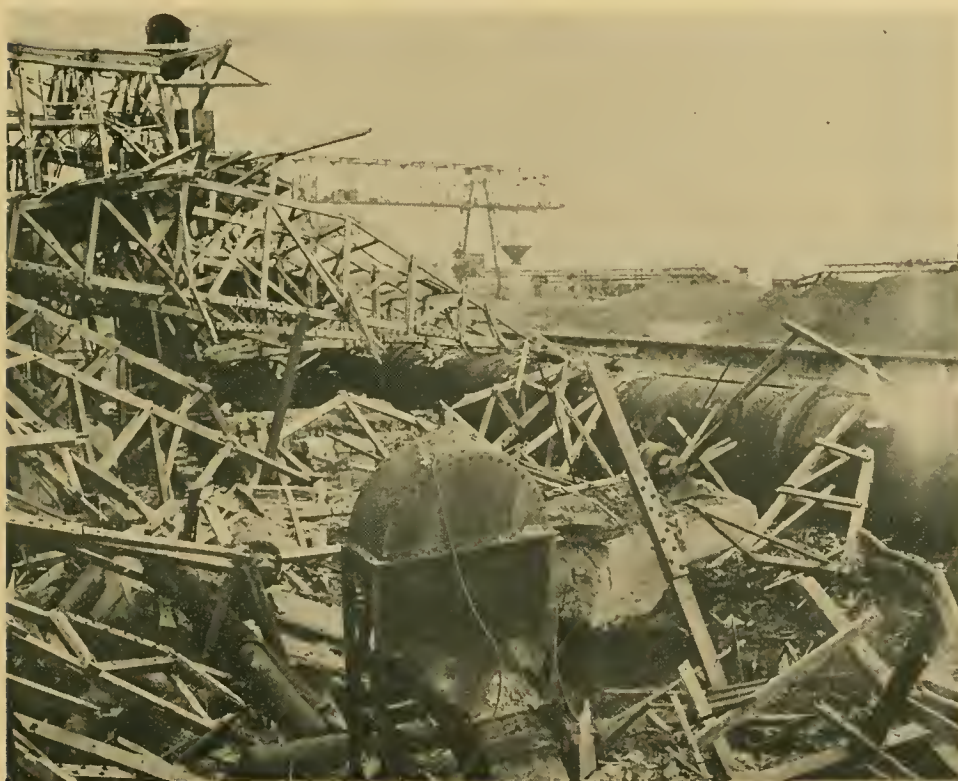
Photo 6—Damaged coal driers blown completely off foundation—Raid number 2

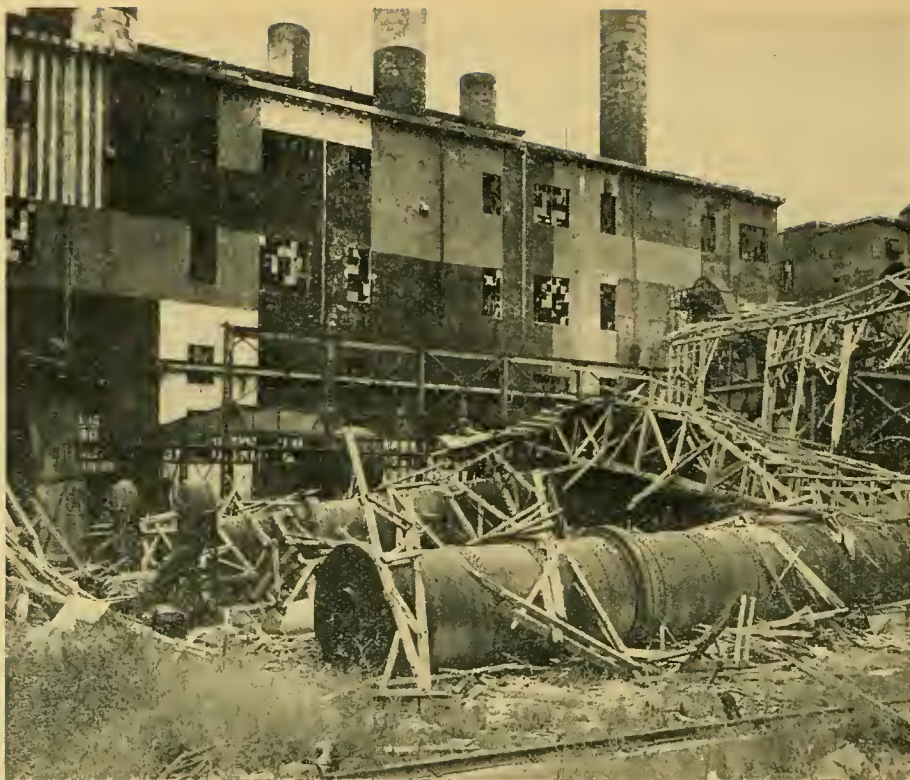
Photo 7—Damaged coal driers and general debris—Note camouflage paint on building—Raid number 2

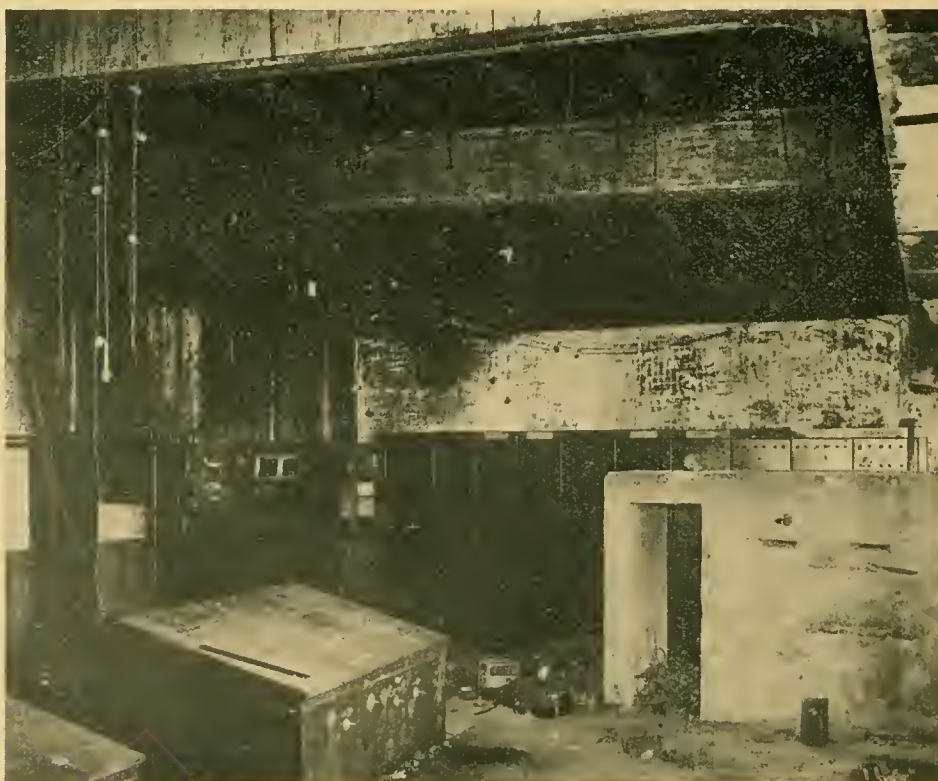
Photo 8—Burned out control room—Note bomb shelter for operators—Raid number 2

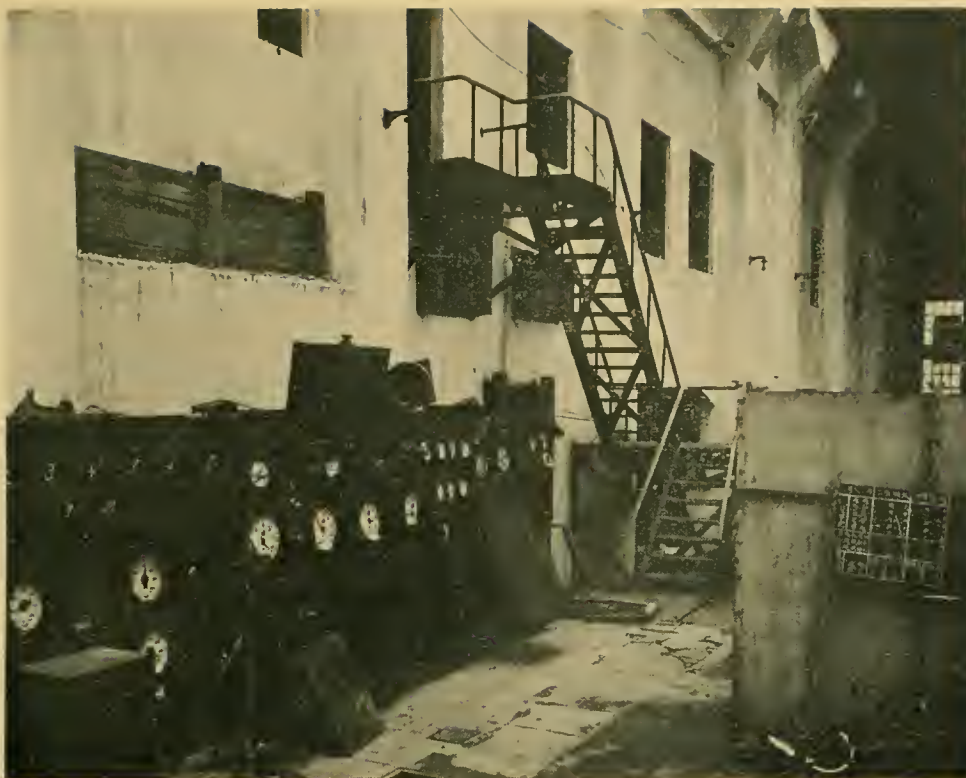
Photo 9—Damaged turbine control instrument board in generator hall—Note blast protective barrier wall—Raid number 2

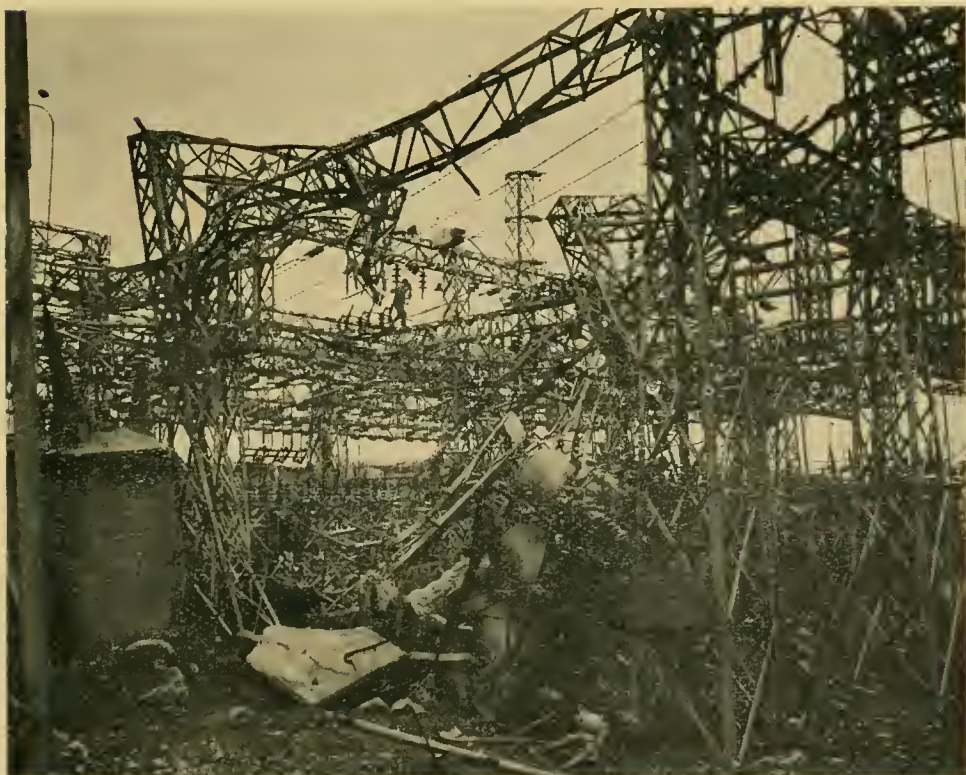
Photo 10—Destroyed O.C.B. and other damage to switch yard—Raid number 2

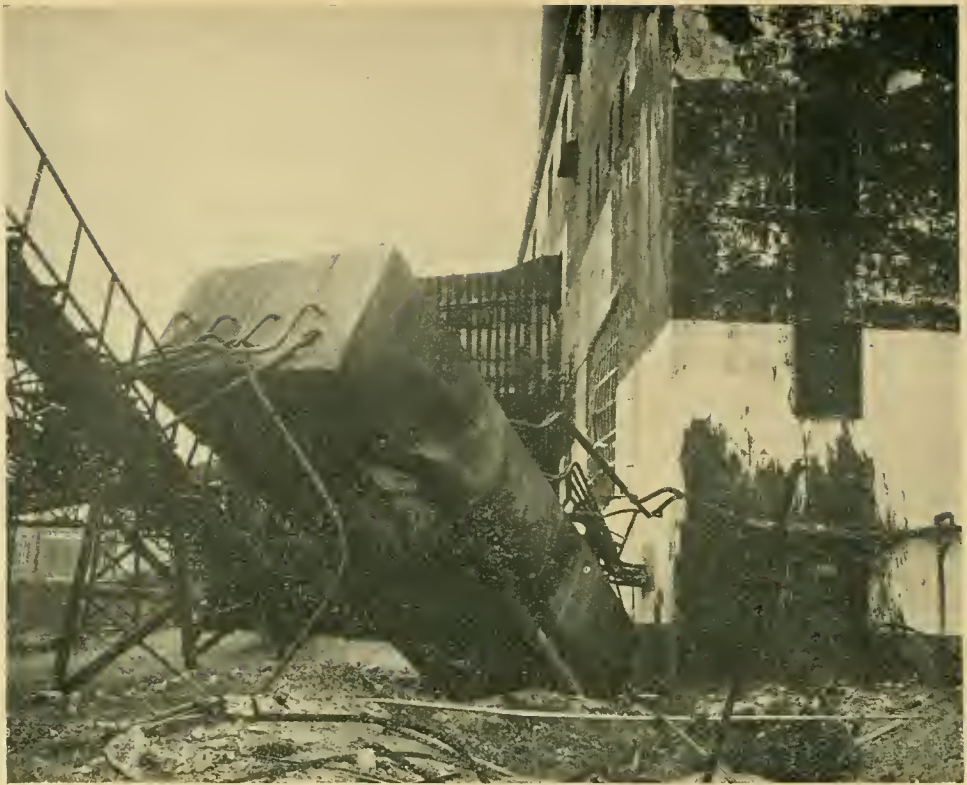
Photo 11—Damaged blow down tank—Raid number 3

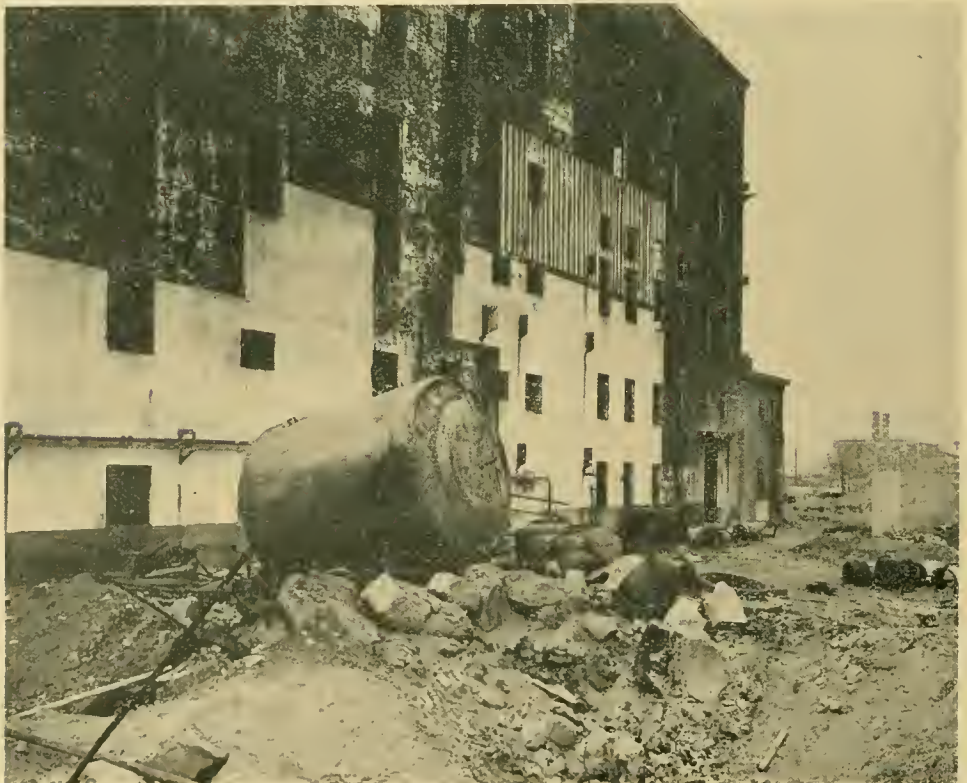
Photo 12—Damaged oil container blown completely out of ground—Raid number 3

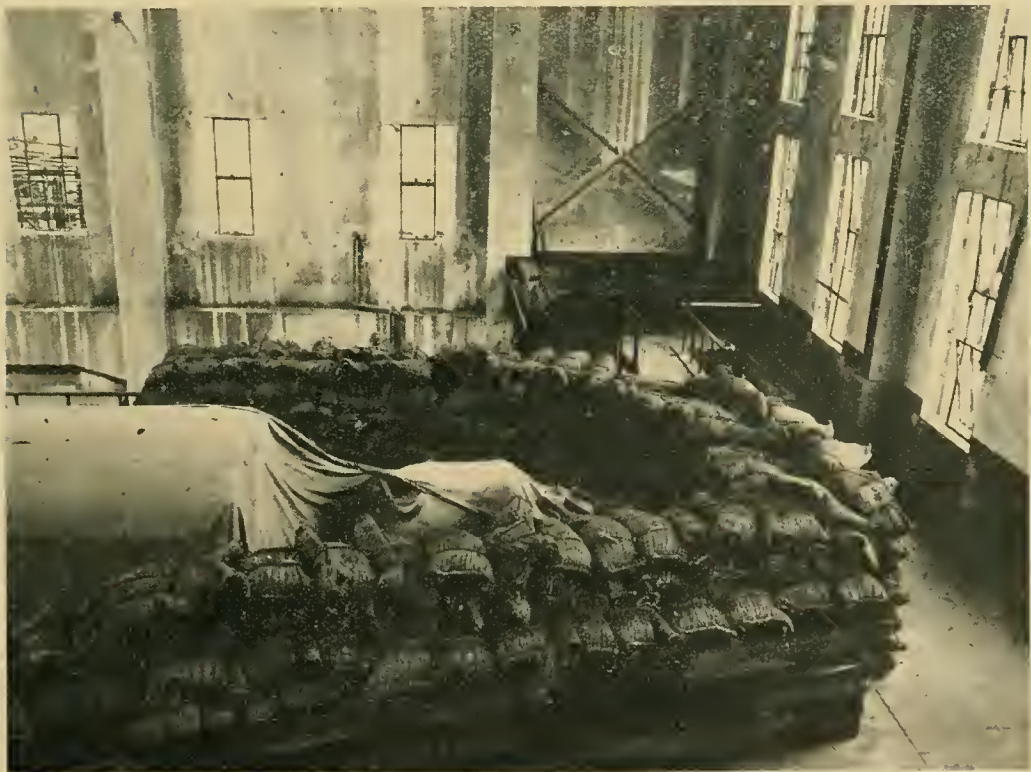
Photo 14—Method of blast protection around turbogenerators

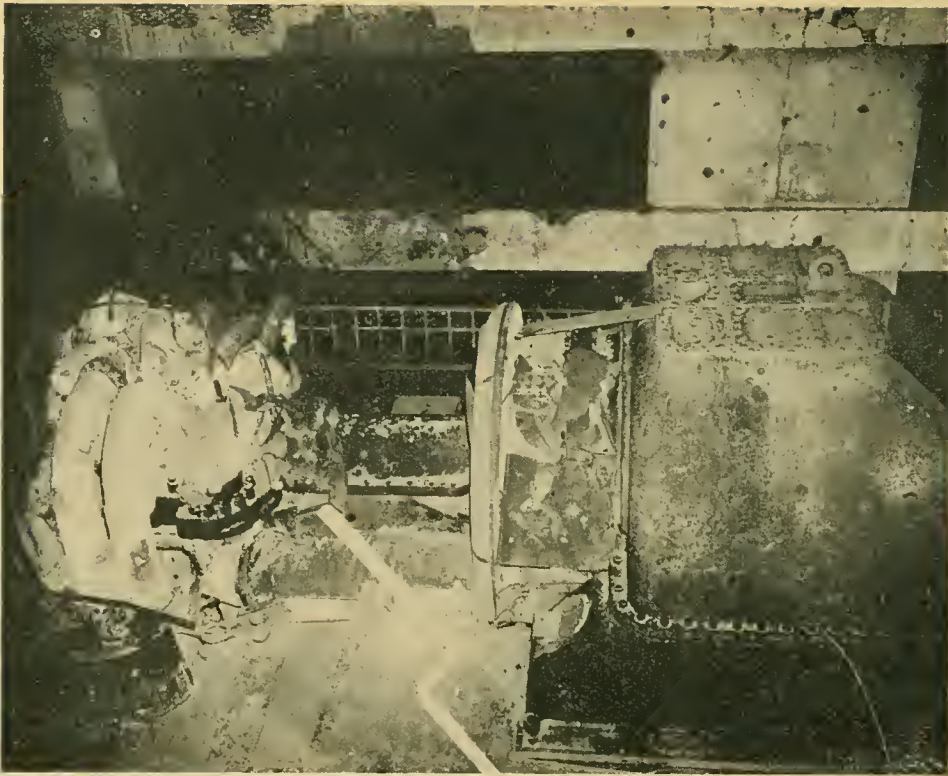
Photo 3—Damaged number 2 steam turbine

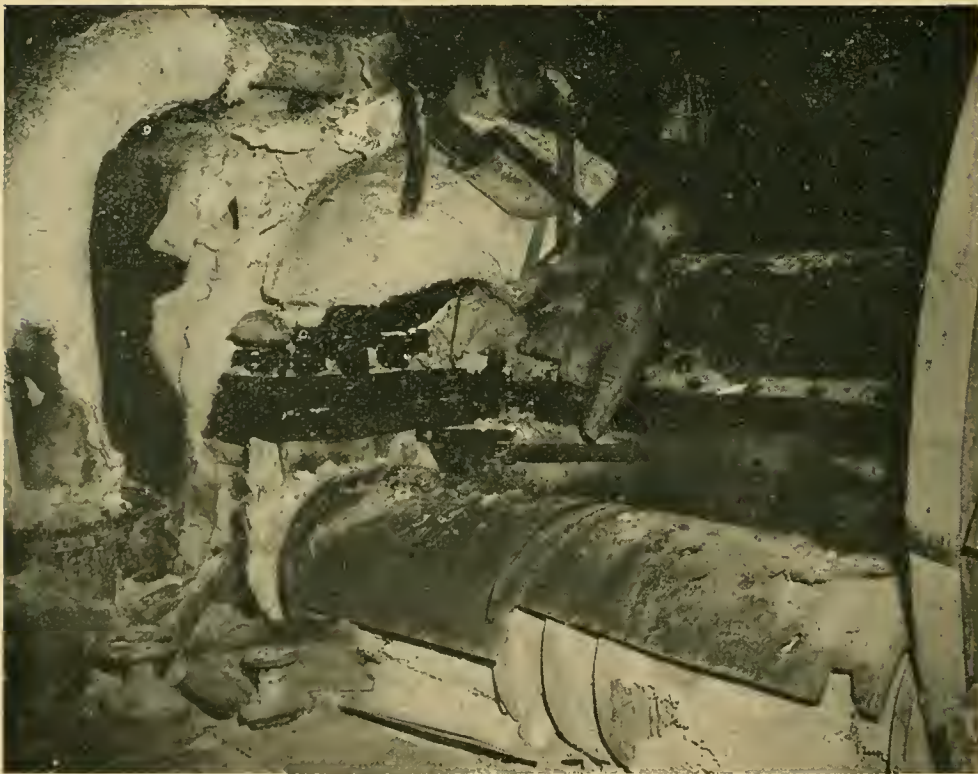
Photo 4—Close view of damaged number 2 steam turbine

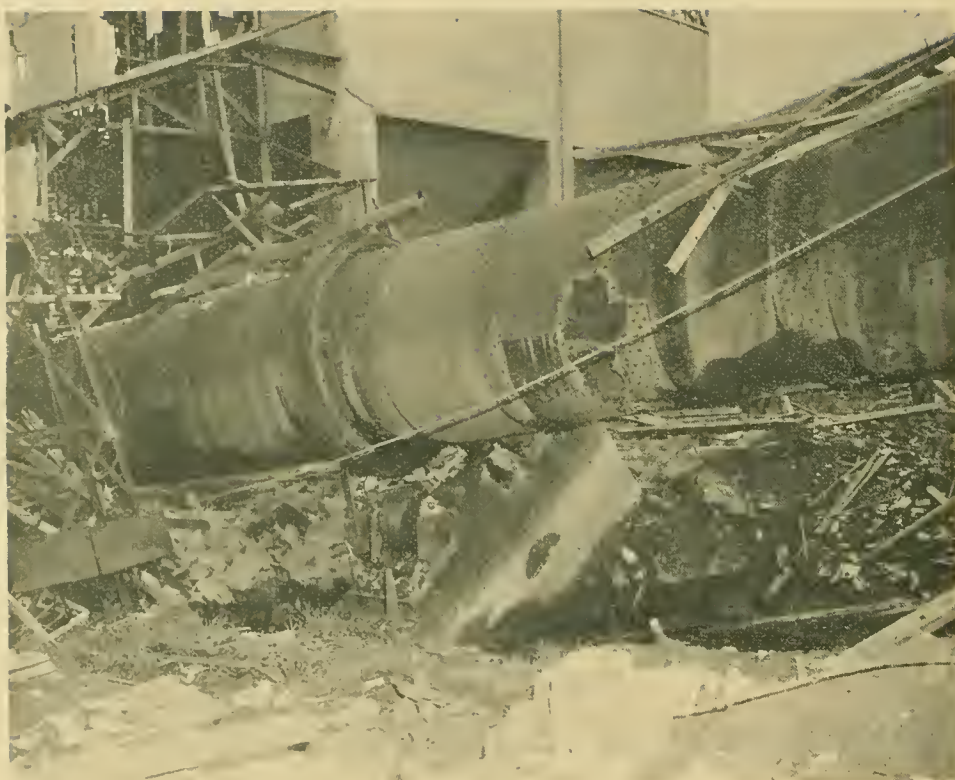
Photo 11—Damaged coal dryer and demolished  
water cooling inlet tunnel

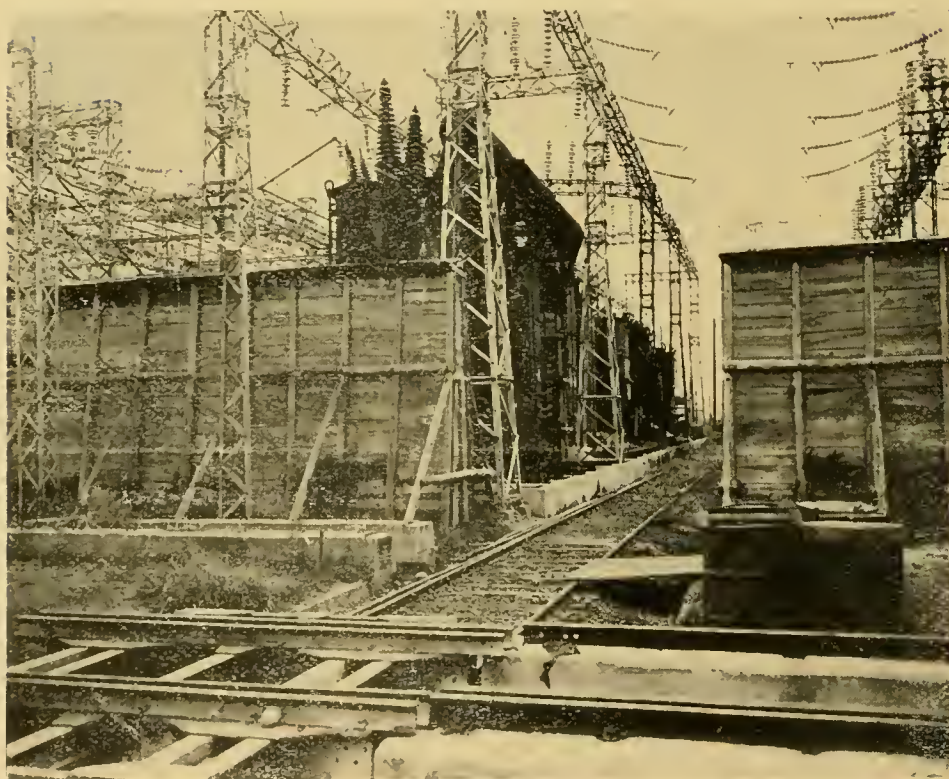
Photo 10—Iwakura—Transformer banks, damaged transformers on far end
